Haul Road Monitoring in Open Pit Mines Using Unmanned Aerial Vehicles: a Case Study at Bald Mountain Mine Site

Filip Medinac¹ · Thomas Bamford¹ · Matthew Hart² · Michal Kowalczyk² · Kamran Esmaeili¹

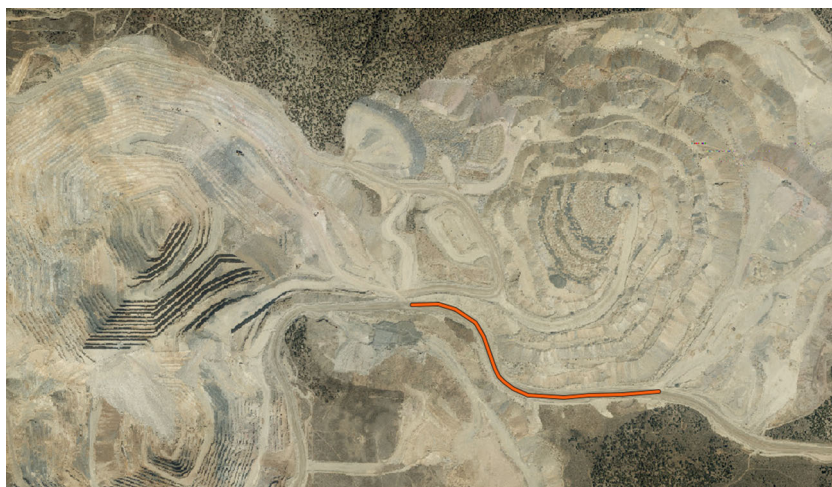
Fig. 1 Haul road section surveyed by drone identified in orange

In this study, a section of the haulage road between the Top 2B pit and its waste rock dump was selected for the unmanned aerial vehicle (UAV) experiment. The section of road was approximately 1.2 km long and 40 m wide. It was selected because it was one of the most utilized roads at the mine. Figure 1 shows the section of road covered. Additional road sections were considered to test the repeatability of the methodology; however, they were not covered due to unfavorable weather conditions during the time available on site.

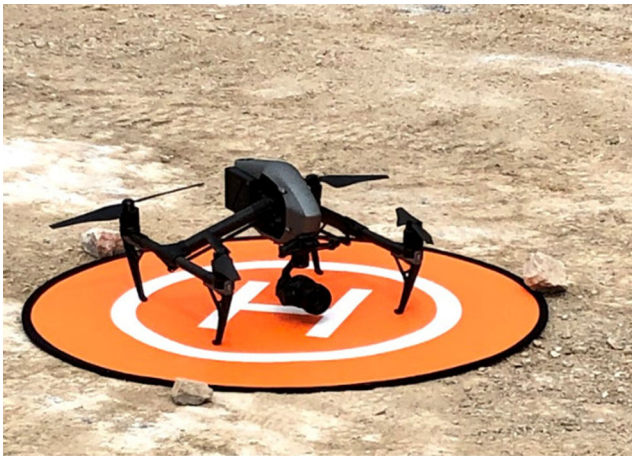
Fig. 2 DJI Inspire 2 UAV

The UAV system used was a DJI Inspire 2, with a flight time of approximately 25 min. It was selected due to its simple setup, fast battery charge, and ease of handling and transporting. Moreover, it was the drone used for routine surveying at the mine site. A Zenmuse X5S 20.8 MP camera was used along with a Olympus M.Zuiko 45mm/1.8 lens to obtain higher resolution images. The lens was upgraded from the default 15 mm/1.7 ASPH prime to provide more image detail due to enlargement. Using a longer focal length reduces the field of view and increases the number of images required to cover the same area [5]. The section of road is located at an elevation ranging from 2225 to 2320 m above sea level, which was accounted for in the experiment by installing high-altitude propellers on the UAV system. These propellers improve performance of the system so that flight

time is not adversely impacted by high altitude. Figure 2 shows the DJI Inspire 2 UAV used for the data collection.

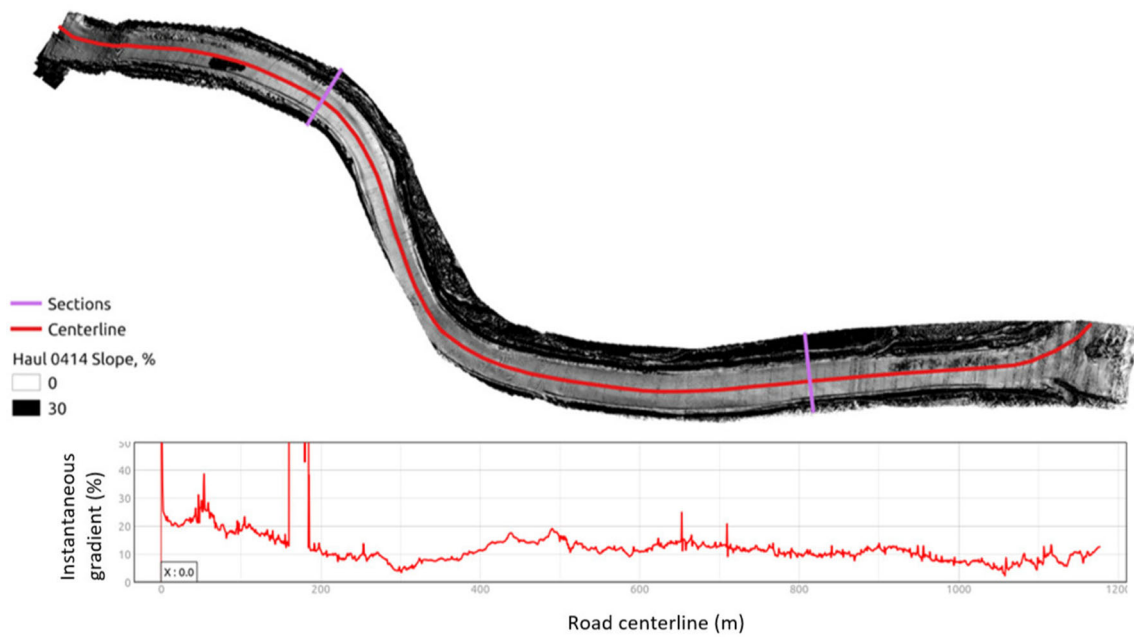
Fig. 4 **a** A slope model of the road; **b** the instantaneous gradient graph along the centerline

Figure 4a presents the slope model of the road and Fig. 4b shows the instantaneous gradient of the road along 1200 m of the road centerline. This can be an indication of the road smoothness/undulating condition. Areas with high frequency of sharp peaks (e.g., ~ 50 m, and 650–720 m along the road centerline) are more undulated than the rest of the road. The sudden peak between 170 and 190 m along the centerline is attributed to the presence of a grader working on the road during the aerial survey. The image masking and data filtering features in OpenDroneMap were not working correctly during processing to remove the grader from data. It is highly recommended that any future work should mask images or filter point cloud data prior to DEM creation. This will ensure that the DEM represents the surface of the road section correctly.
